From: David Keith <dkeith@anchorqea.com>
Sent: Friday, June 12, 2015 6:45 PM
To: Miller, Gary; Leos, Valmichael; Sanchez, Carlos
Cc: Dave Moreira (dmoreira@wm.com); Phil Slowiak; Wendell Mears; John Verduin; John Laplante; Holly Samaha
Subject: RE: SJRWP-photos of cap liner exposure 6/11/15
Attachments: 11June2015 Harris Co Incident_1535_150612.pdf

Figure 3
 January 2015 Semi-Annual Inspection Survey
 Post TCRA Semi-Annual Inspection (January 2015)
 San Jacinto River Waste Pits Superfund Site

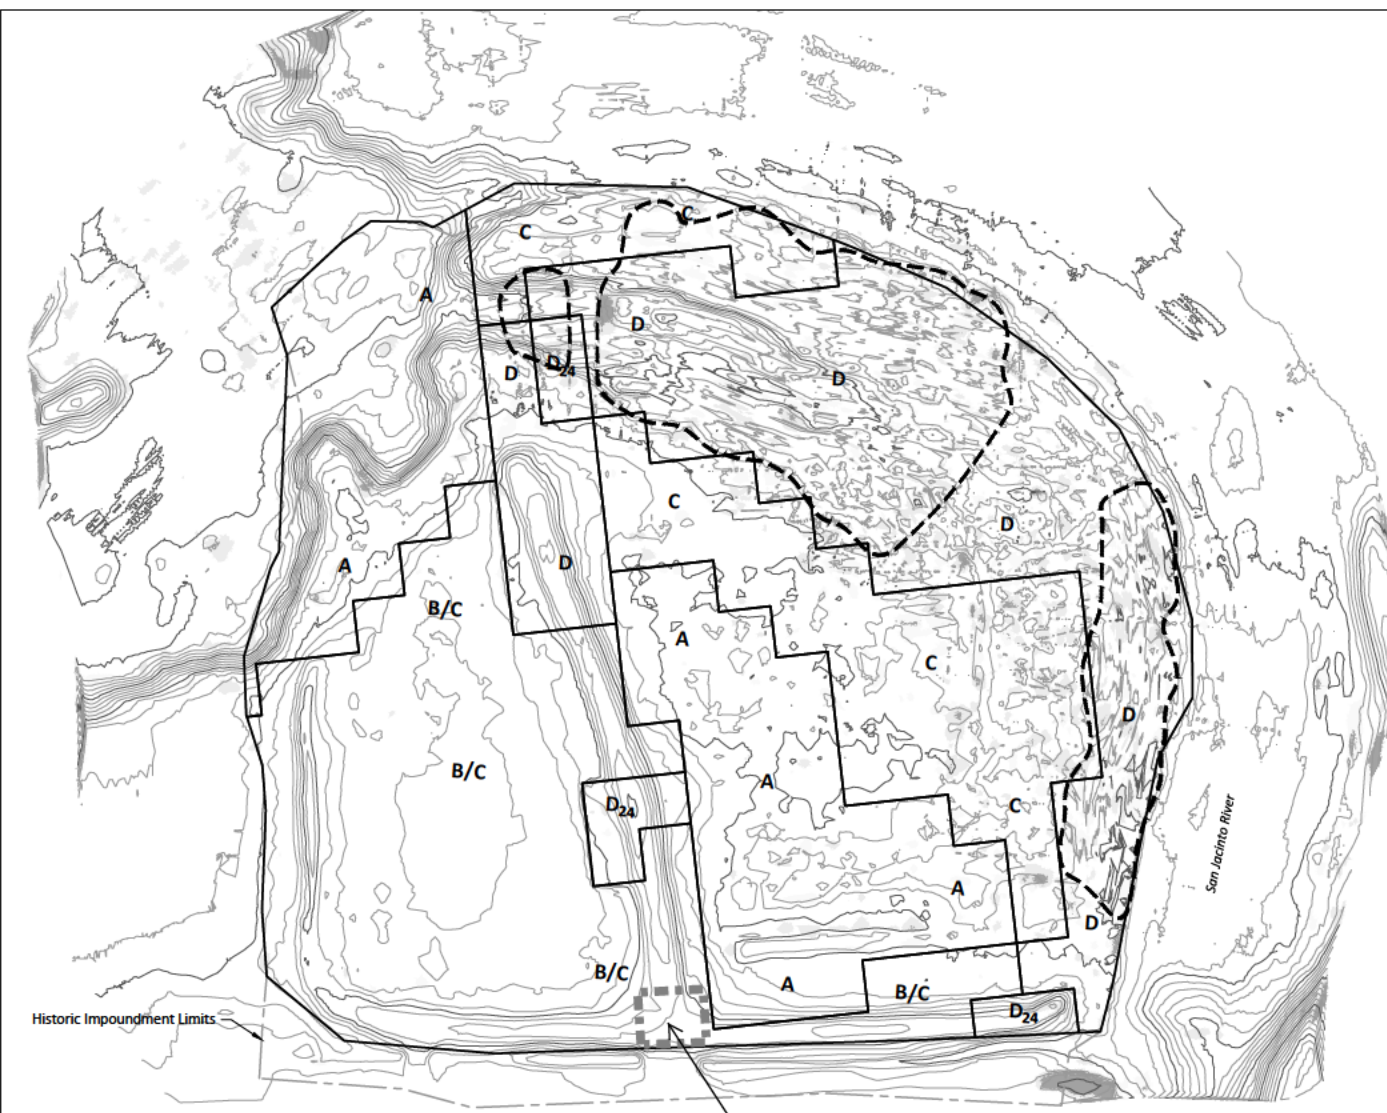
Area where Harris County Photos taken June 11, 2015. Ramp and stockpile area for TCRA construction

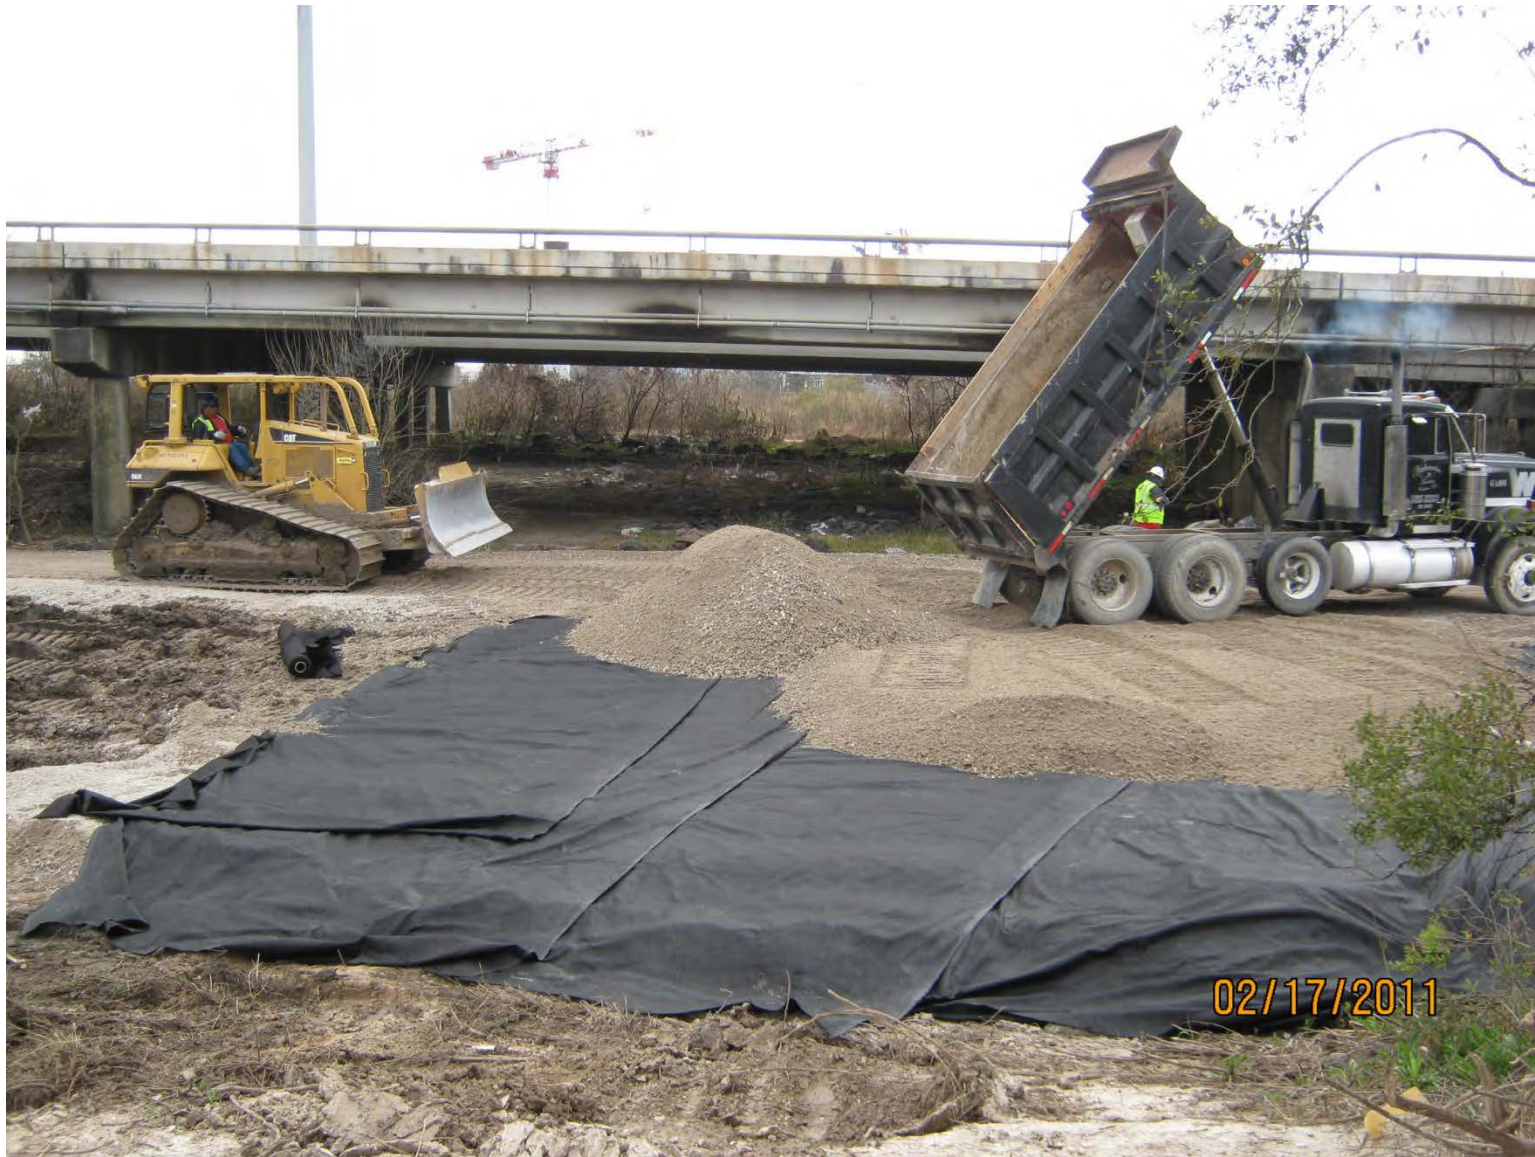
Constructing east ramp to stockpile area. Note multiple layers of geotextile are installed before crushed stone aggregate.

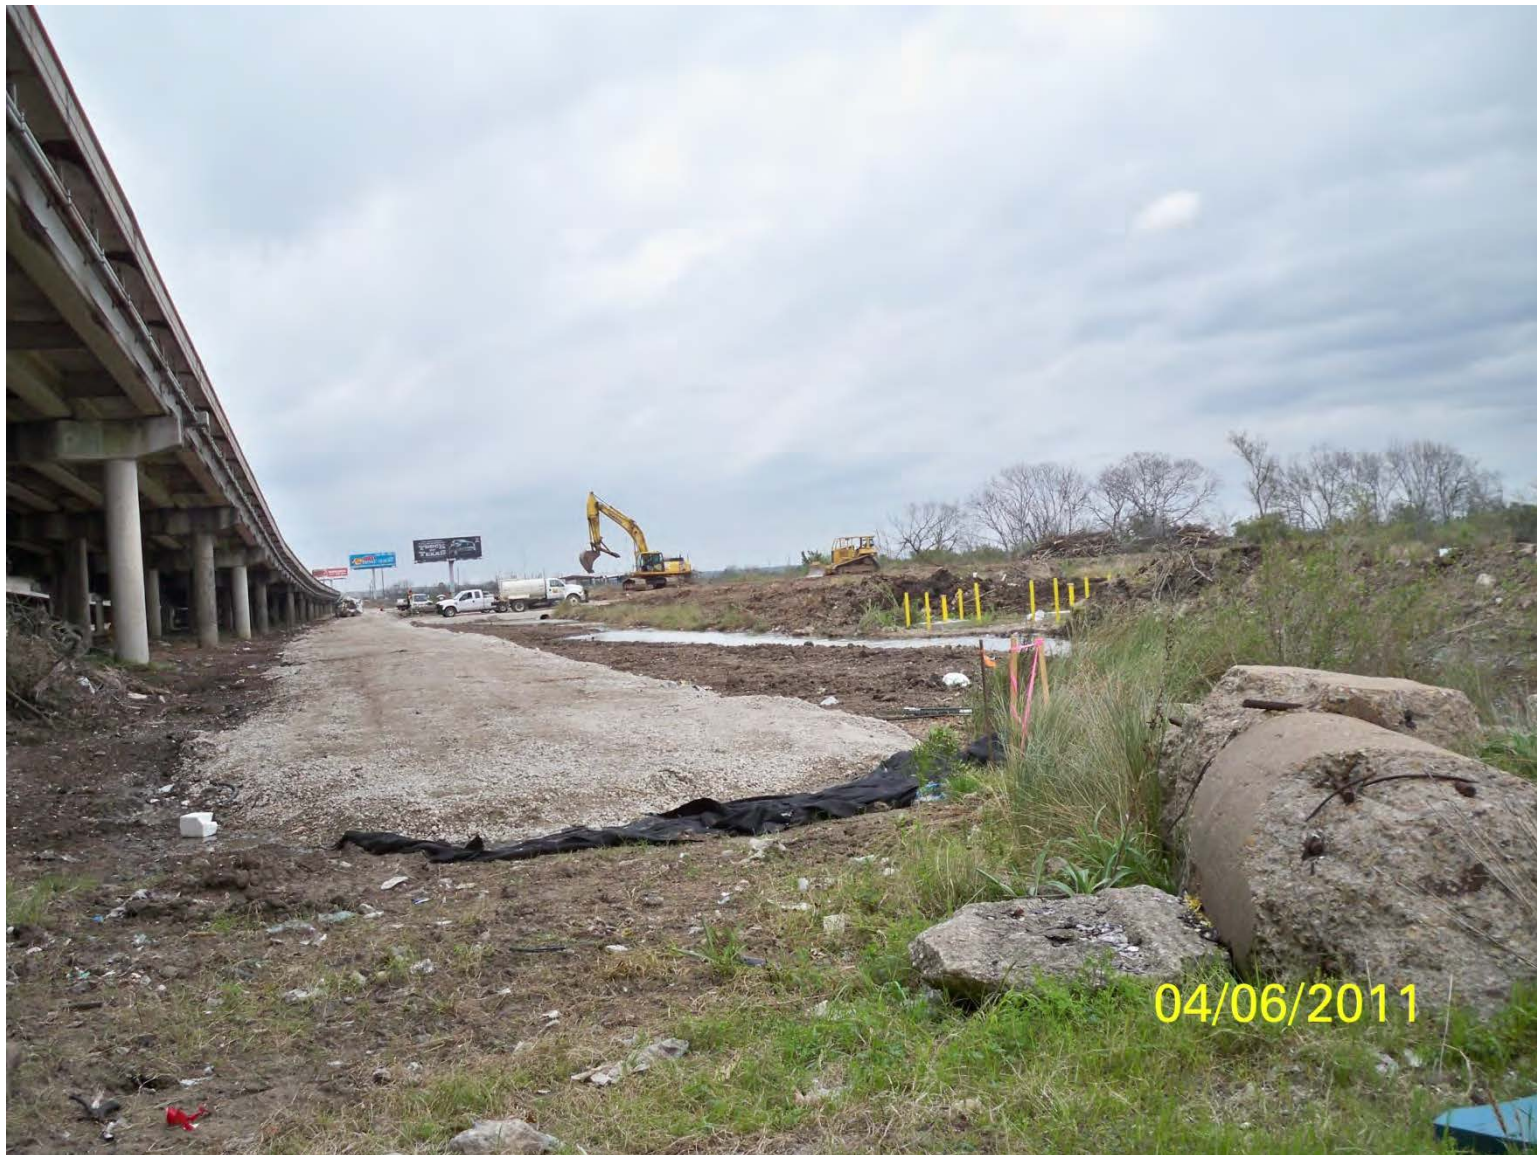
Working atop the stockpile area. Note geotextile under aggregate on the road.

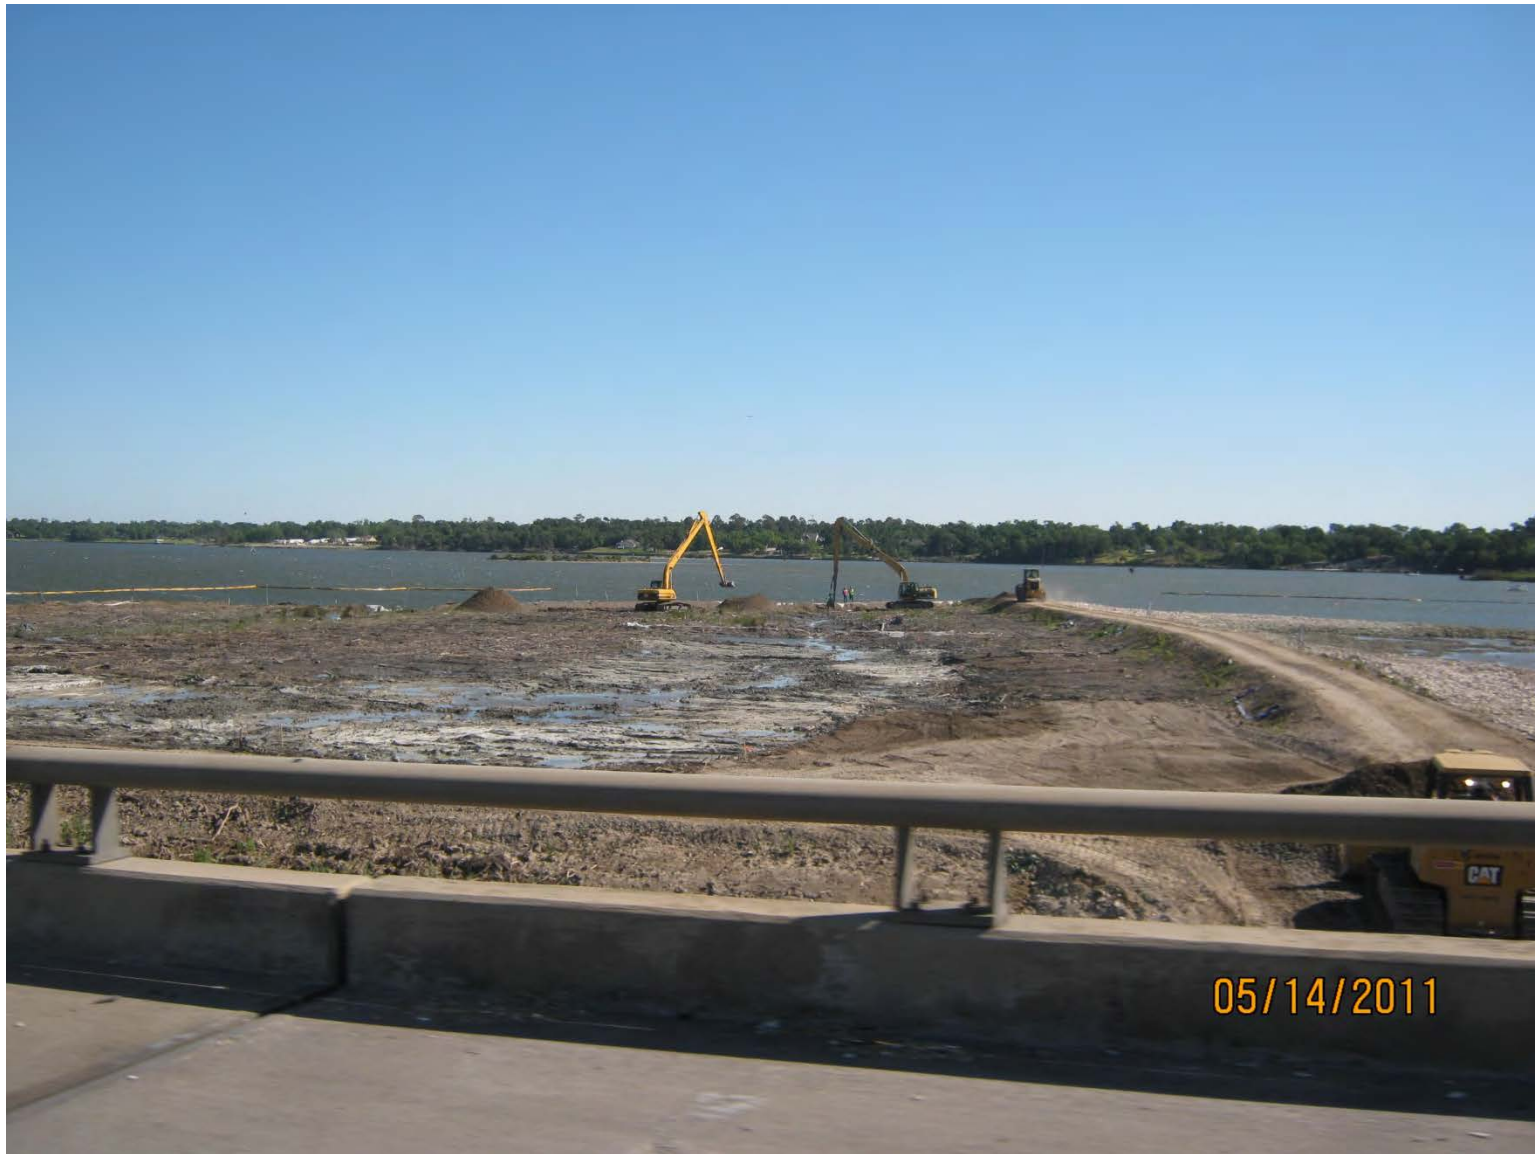
Photo from I-10 Bridge looking north along central berm. Note construction stockpile area aggregate and work pad installation

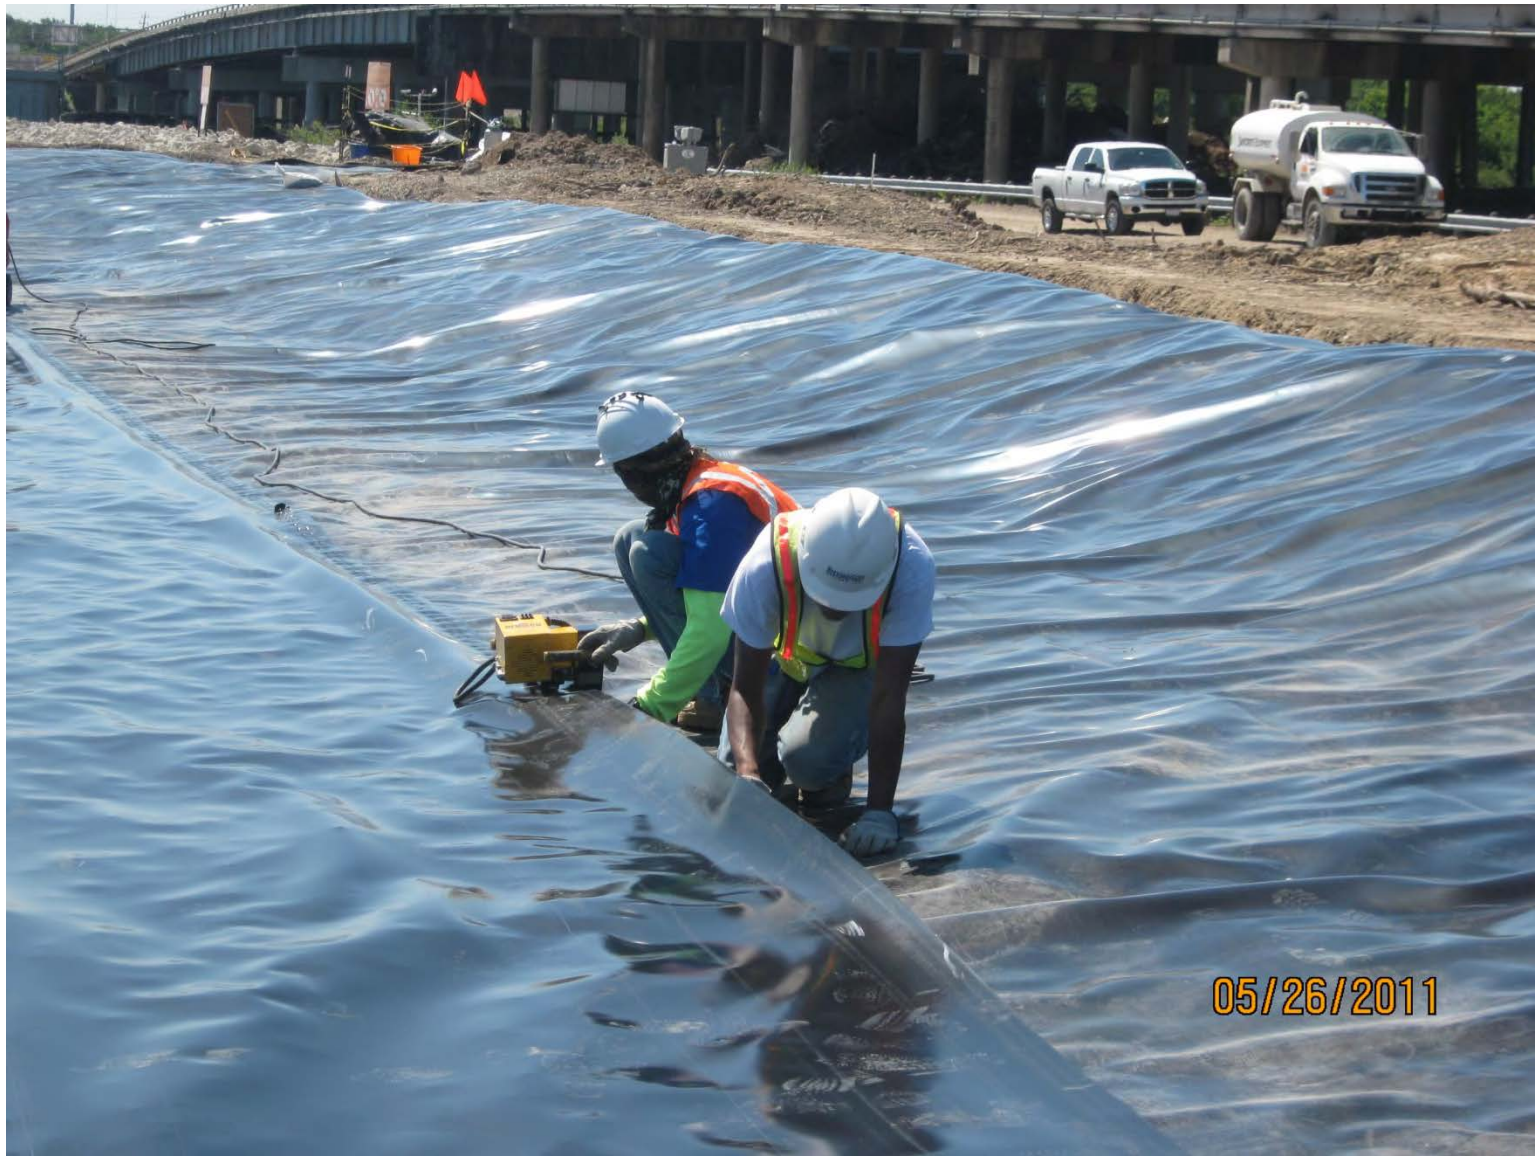
Seaming geomembrane. Looking east southeast at the intersection of the south and central berms and the stockpile area. Note geomembrane installed over a 12 ounce geotextile with edges buried in a trench.

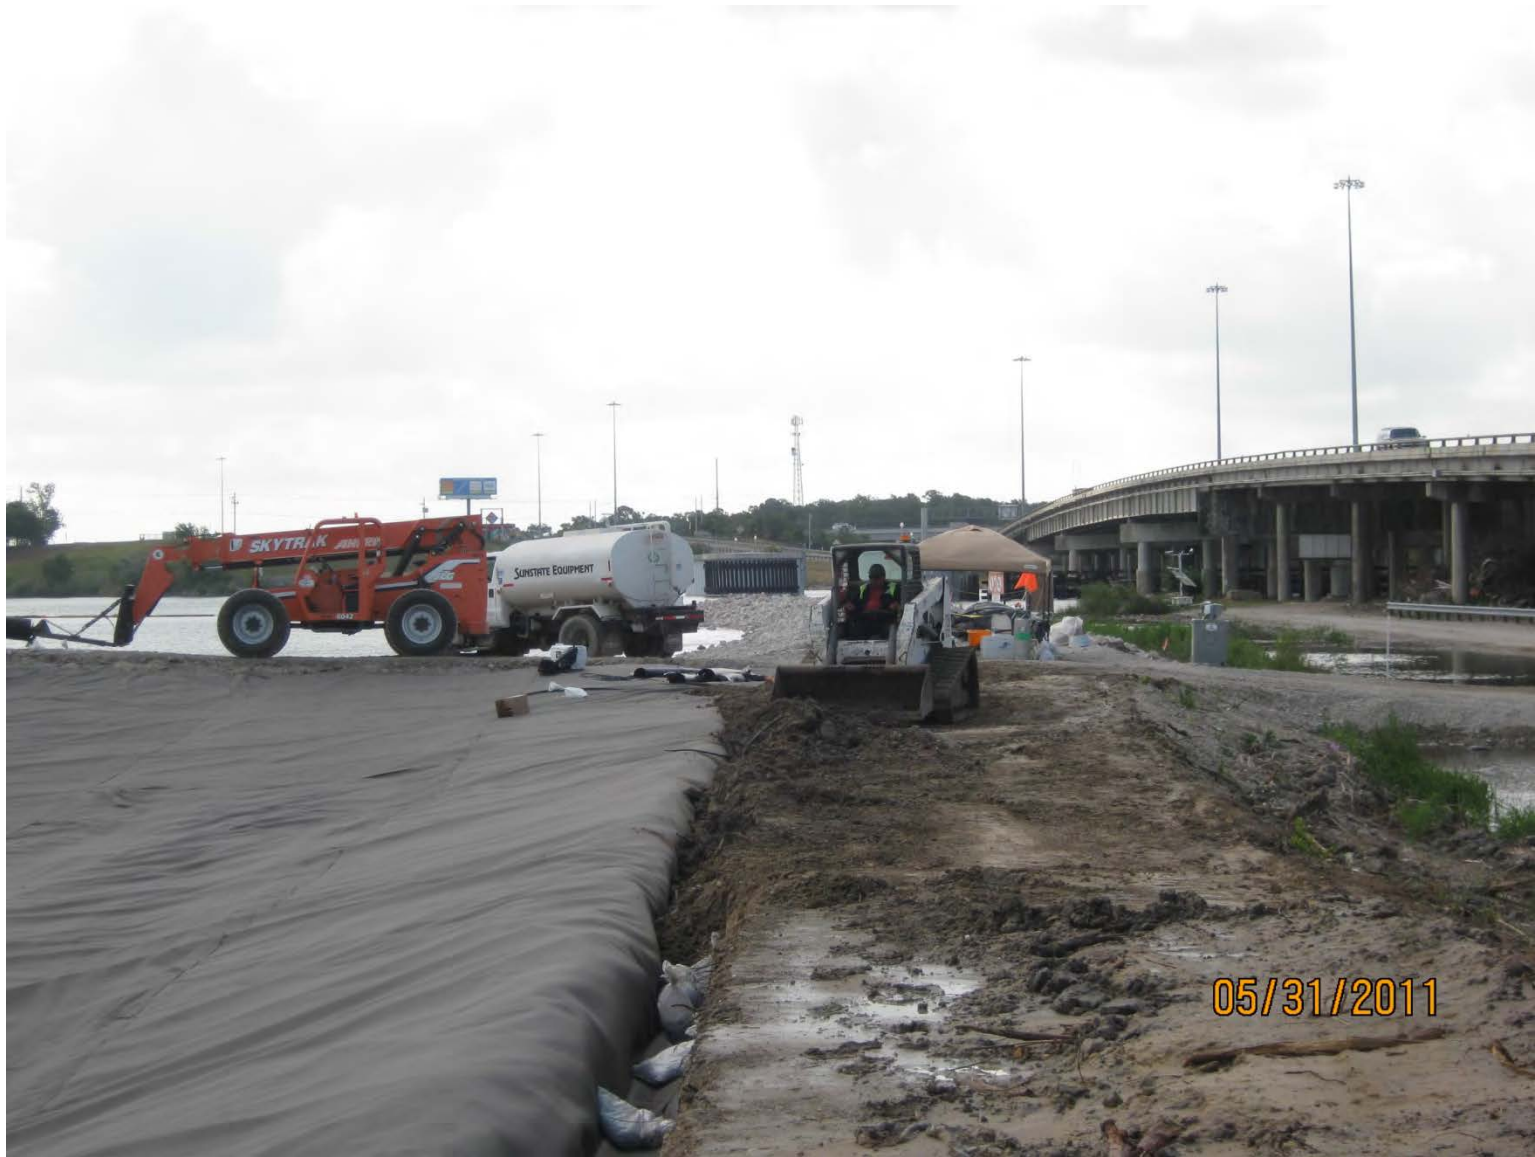
Standing atop south berm looking east at the stockpile area. Note fabric pulled into trench to anchor two layers of geotextile and geomembrane to the left and fabric fold to the right of the berm crest.

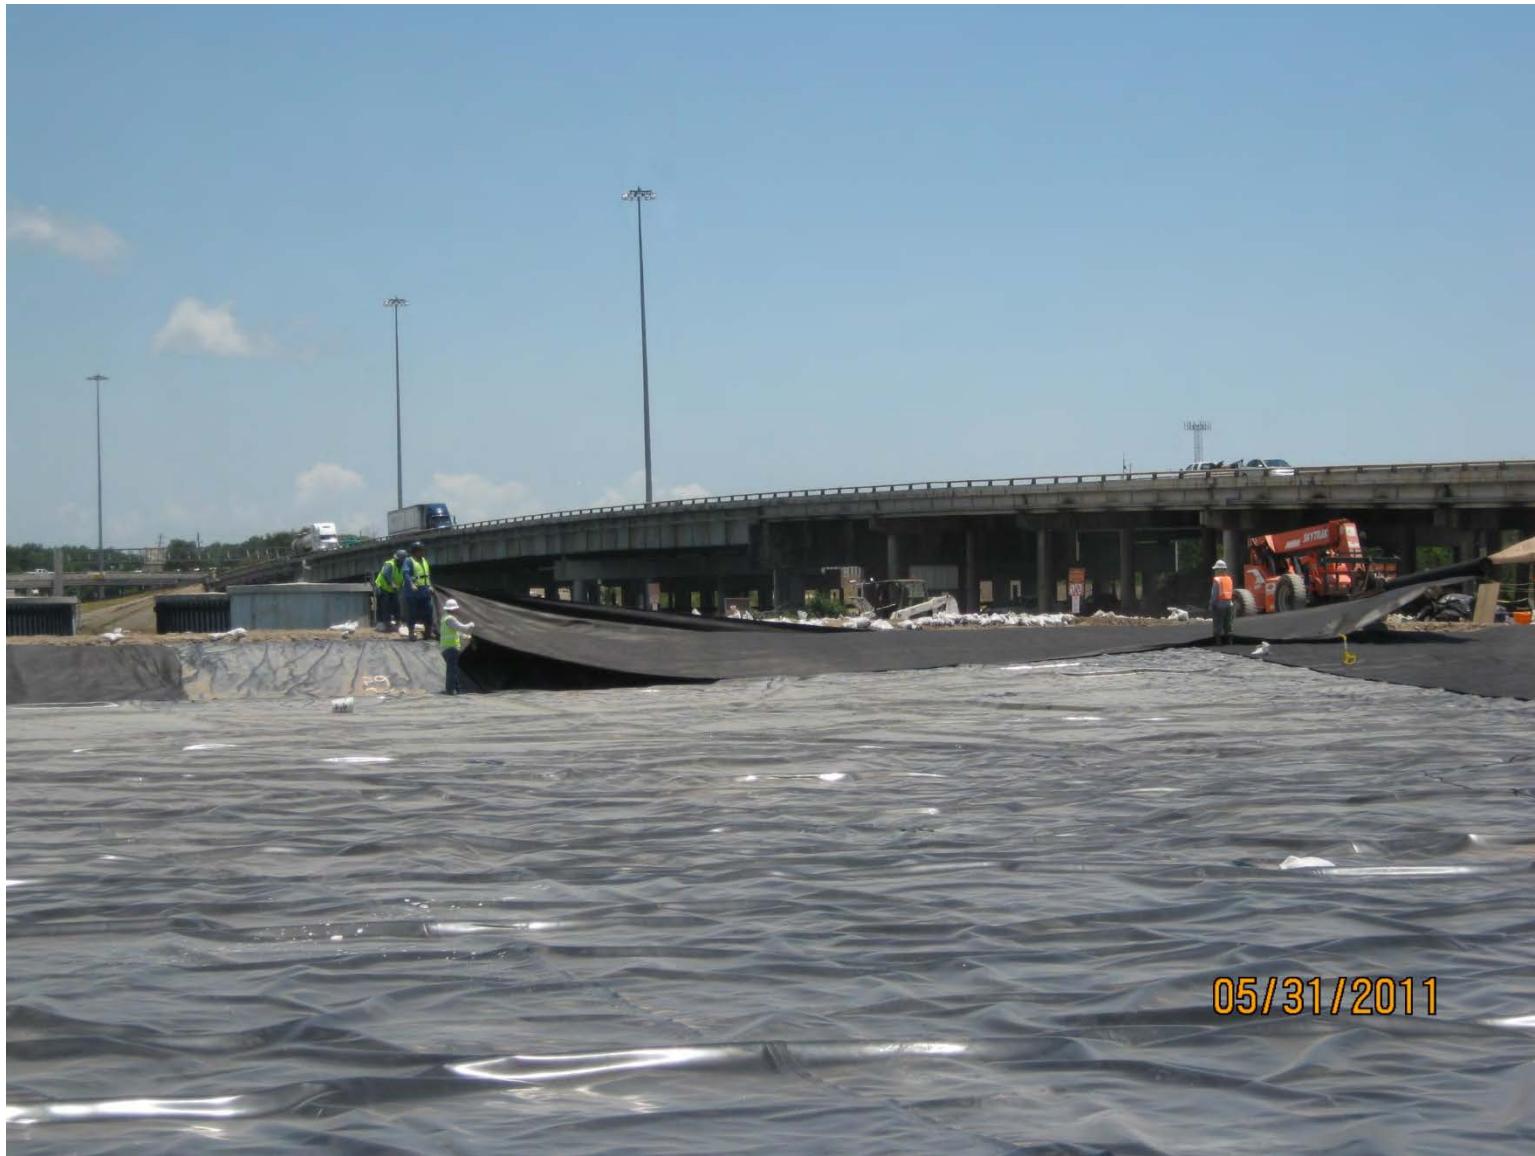
Protective cushion geotextile layer added over geomembrane. Looking southeast toward the stockpile area on the central berm.

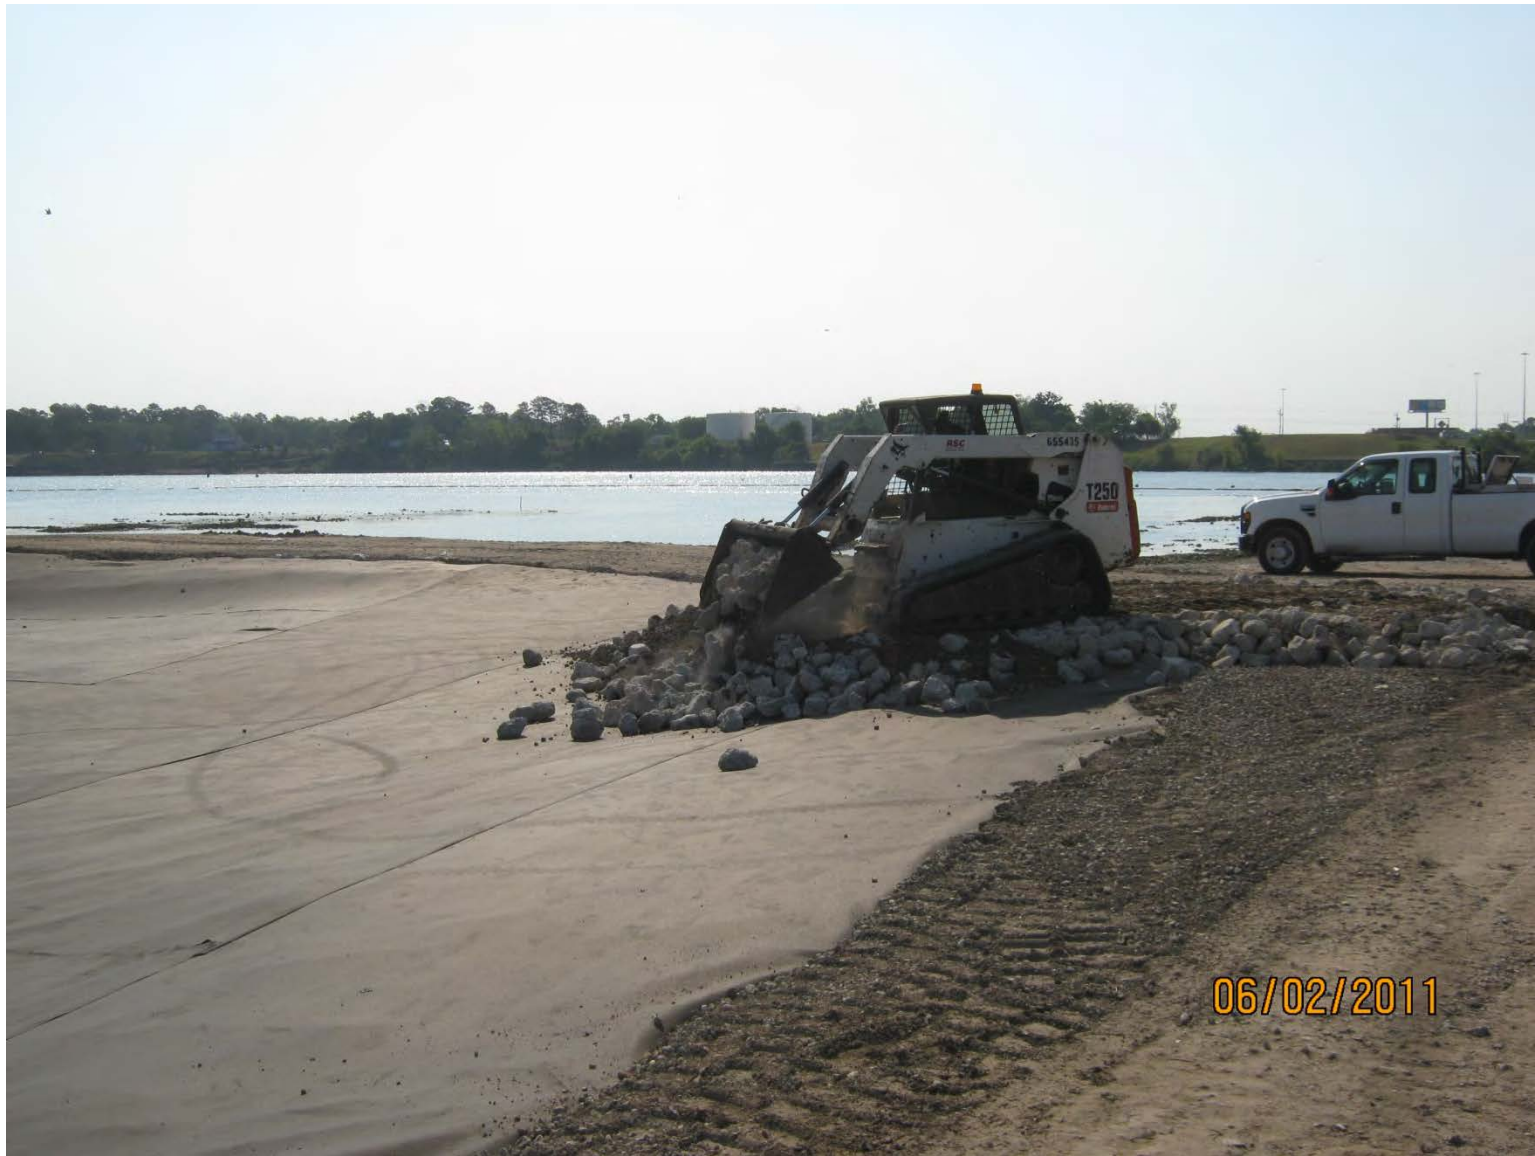
Stone placed atop second layer of geotextile at southeast corner of the western cell and the stockpile area. Note geomembrane trench.

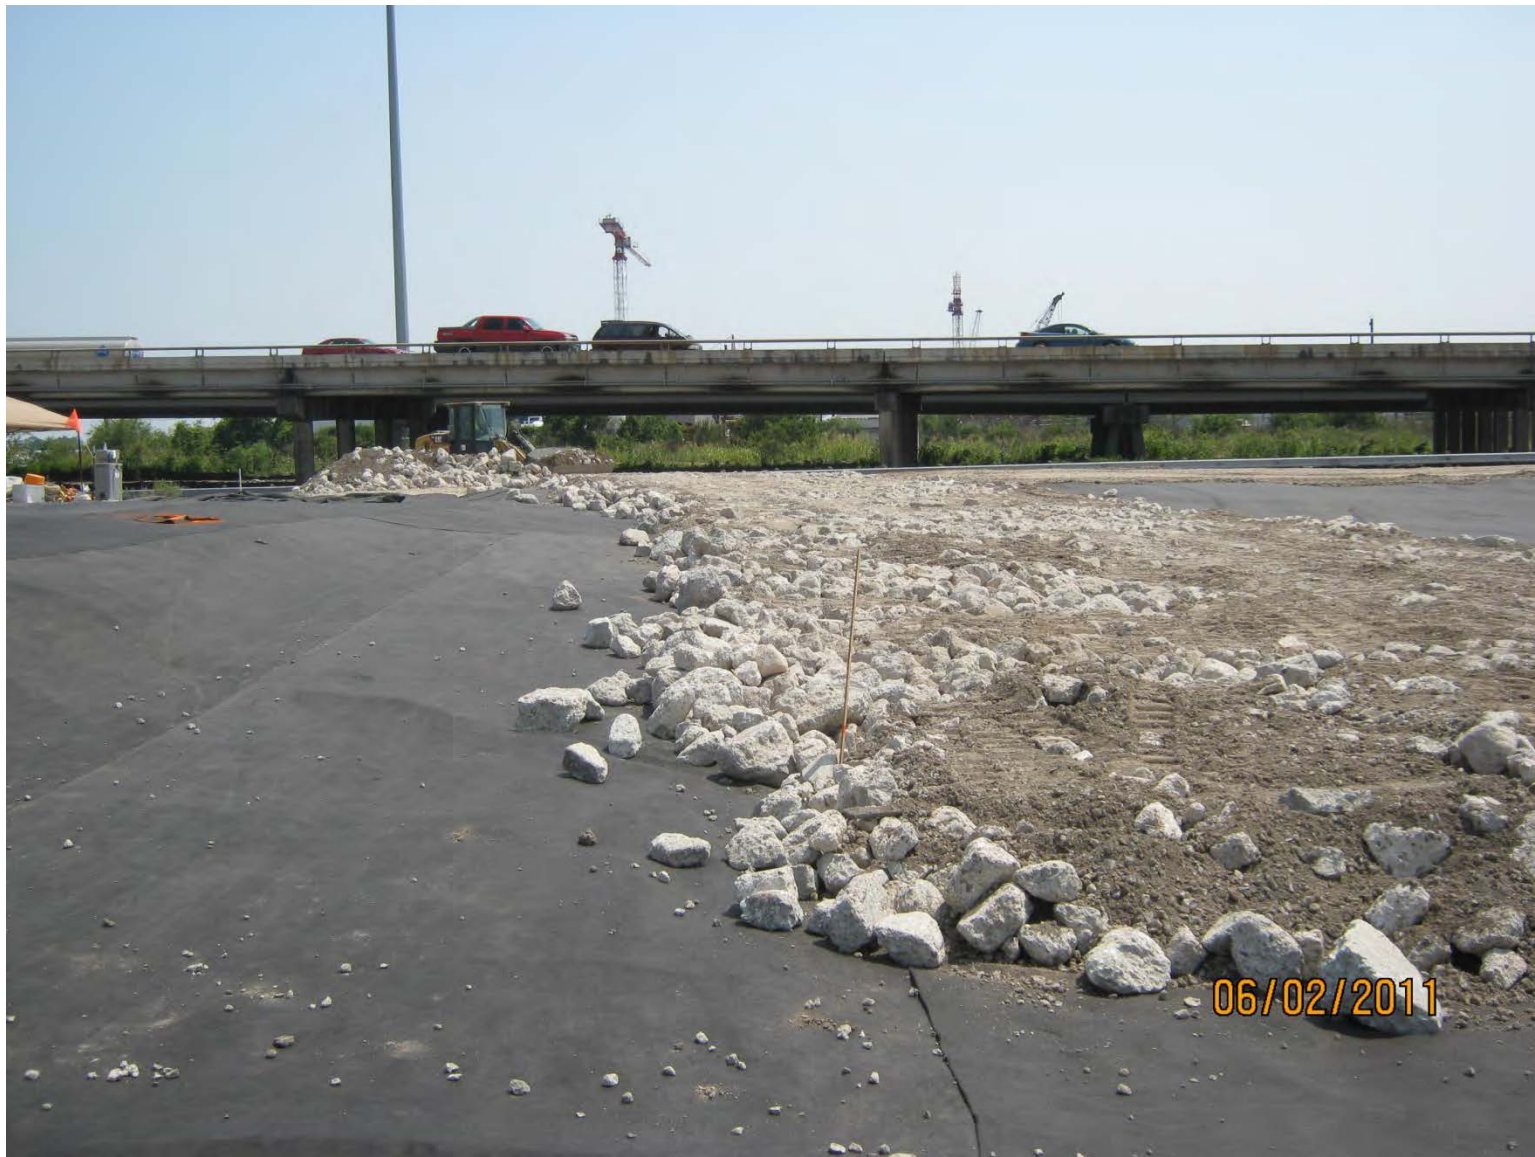
Armor stone being placed onto second layer of geotextile, looking south along central berm to the stockpile area.

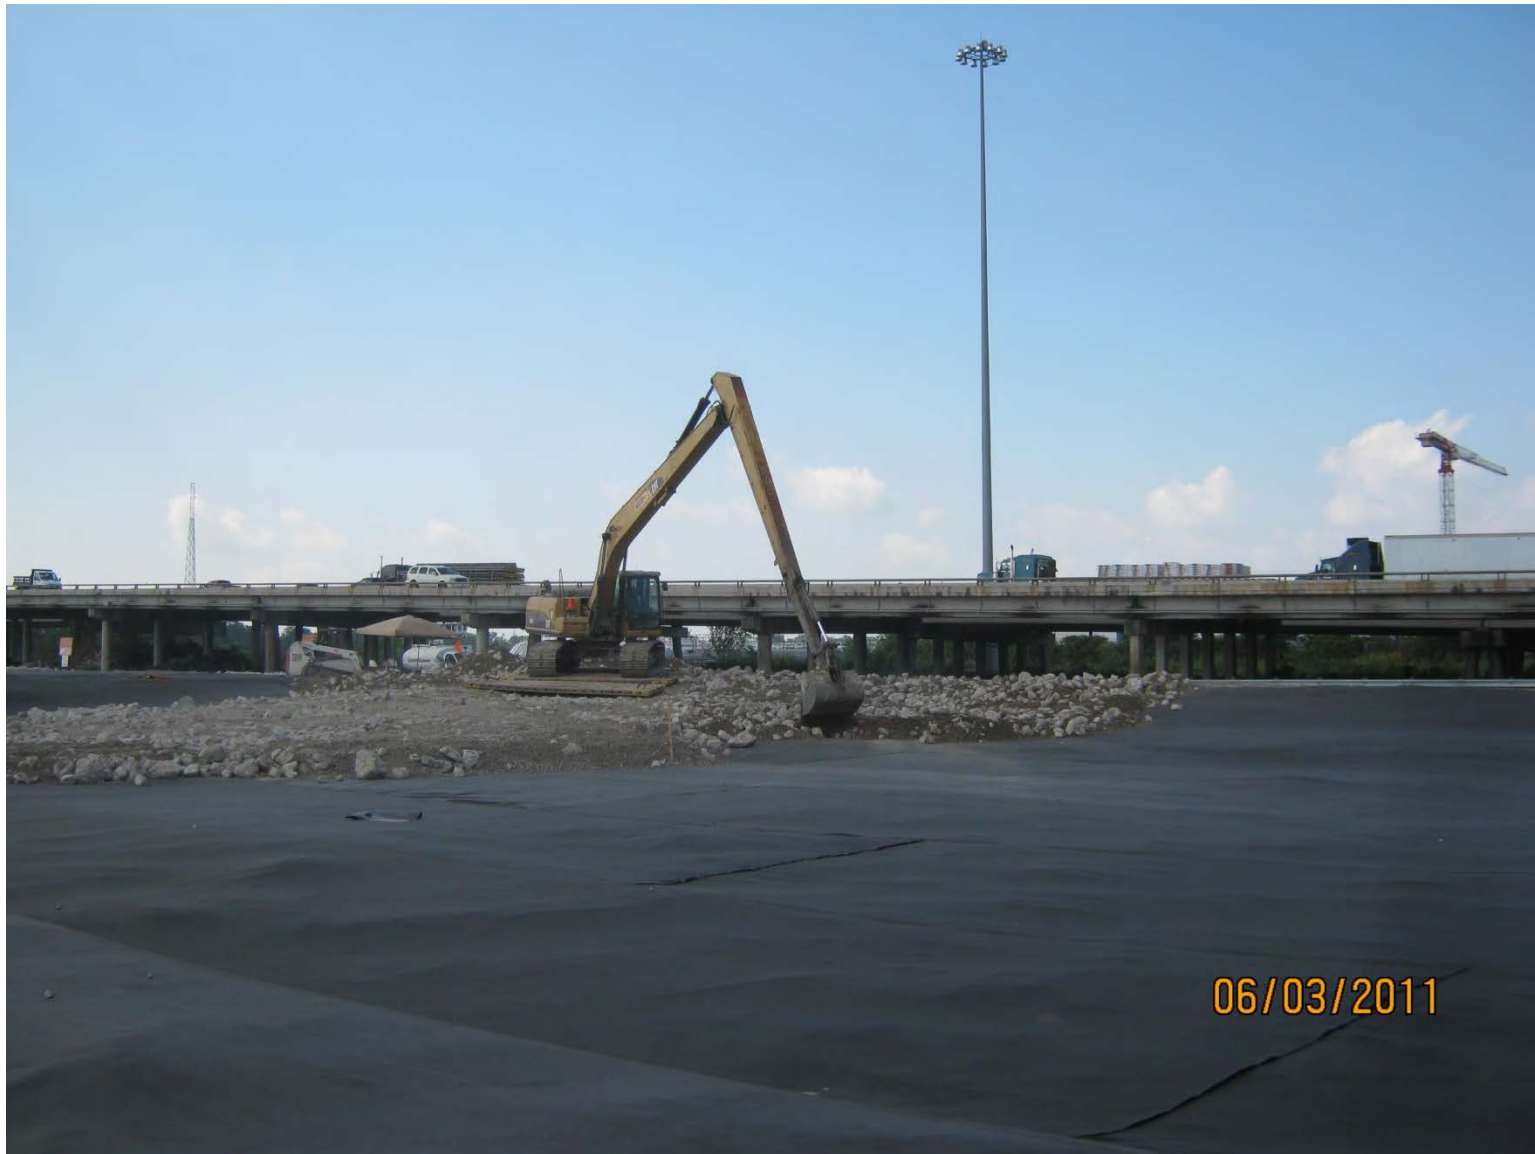
Excavator working from the stockpile area, placing armor stone on the second layer of geotextile. Photo looking south.

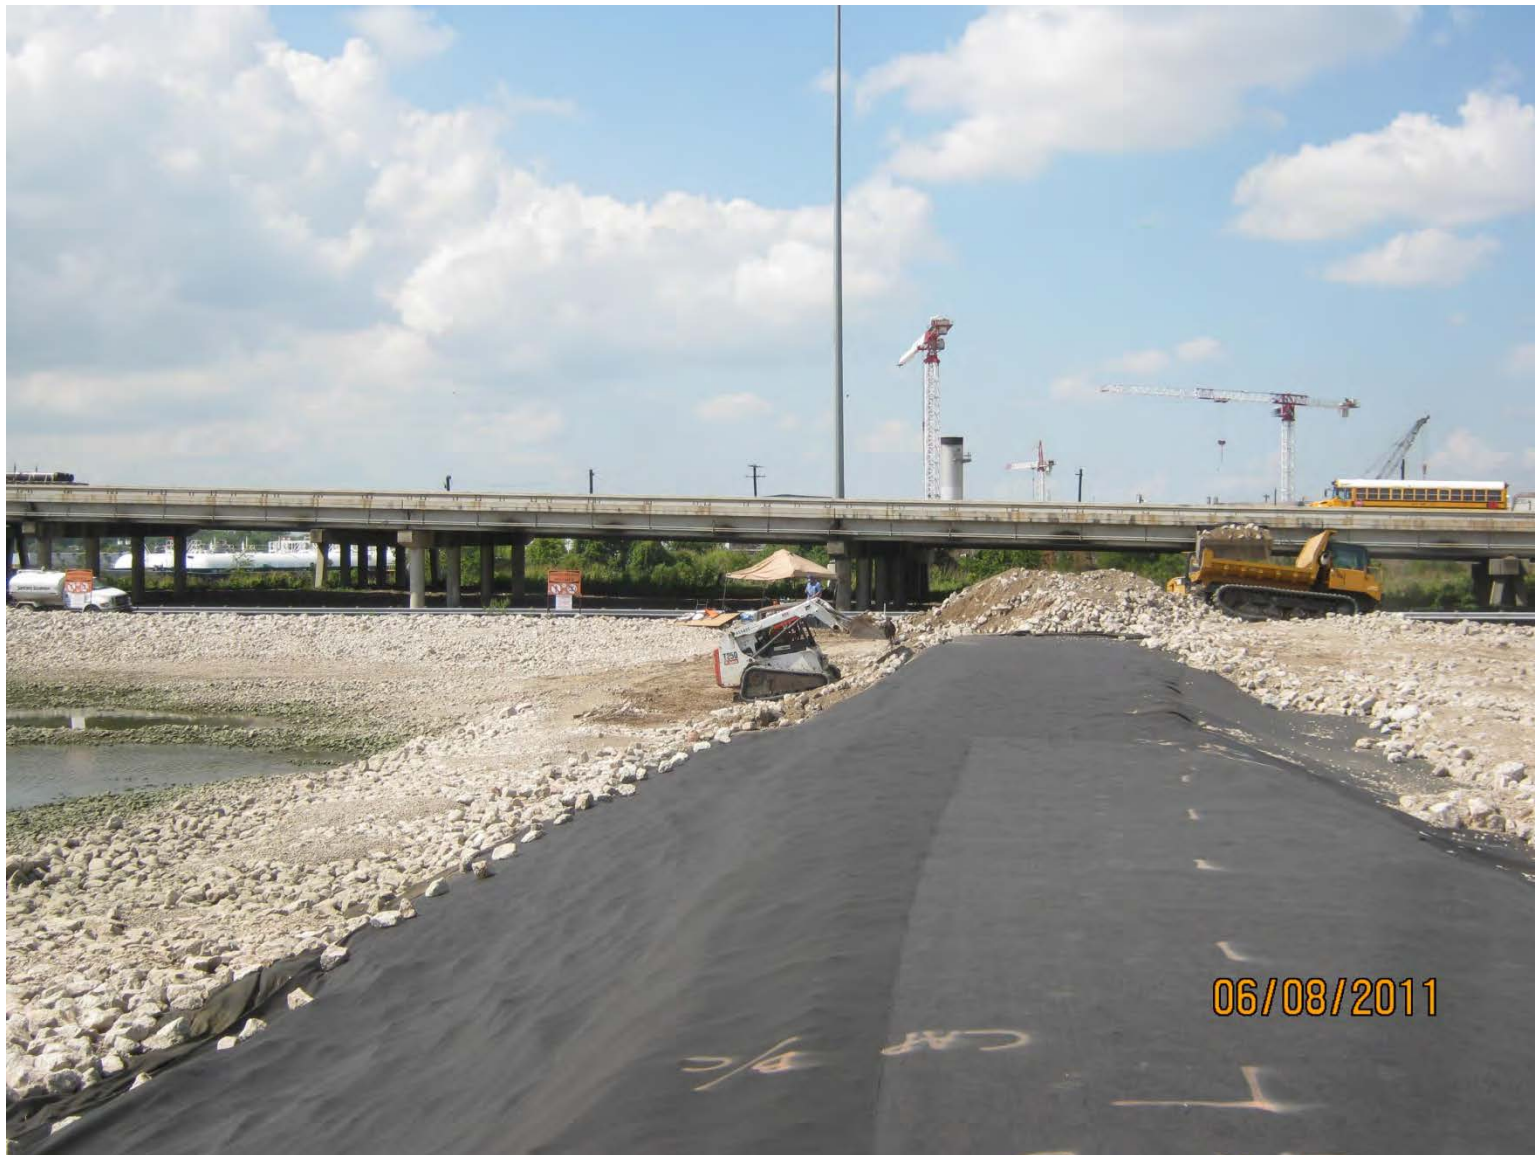
Geotextile and armor stone placed along central berm, look south toward the stockpile area.

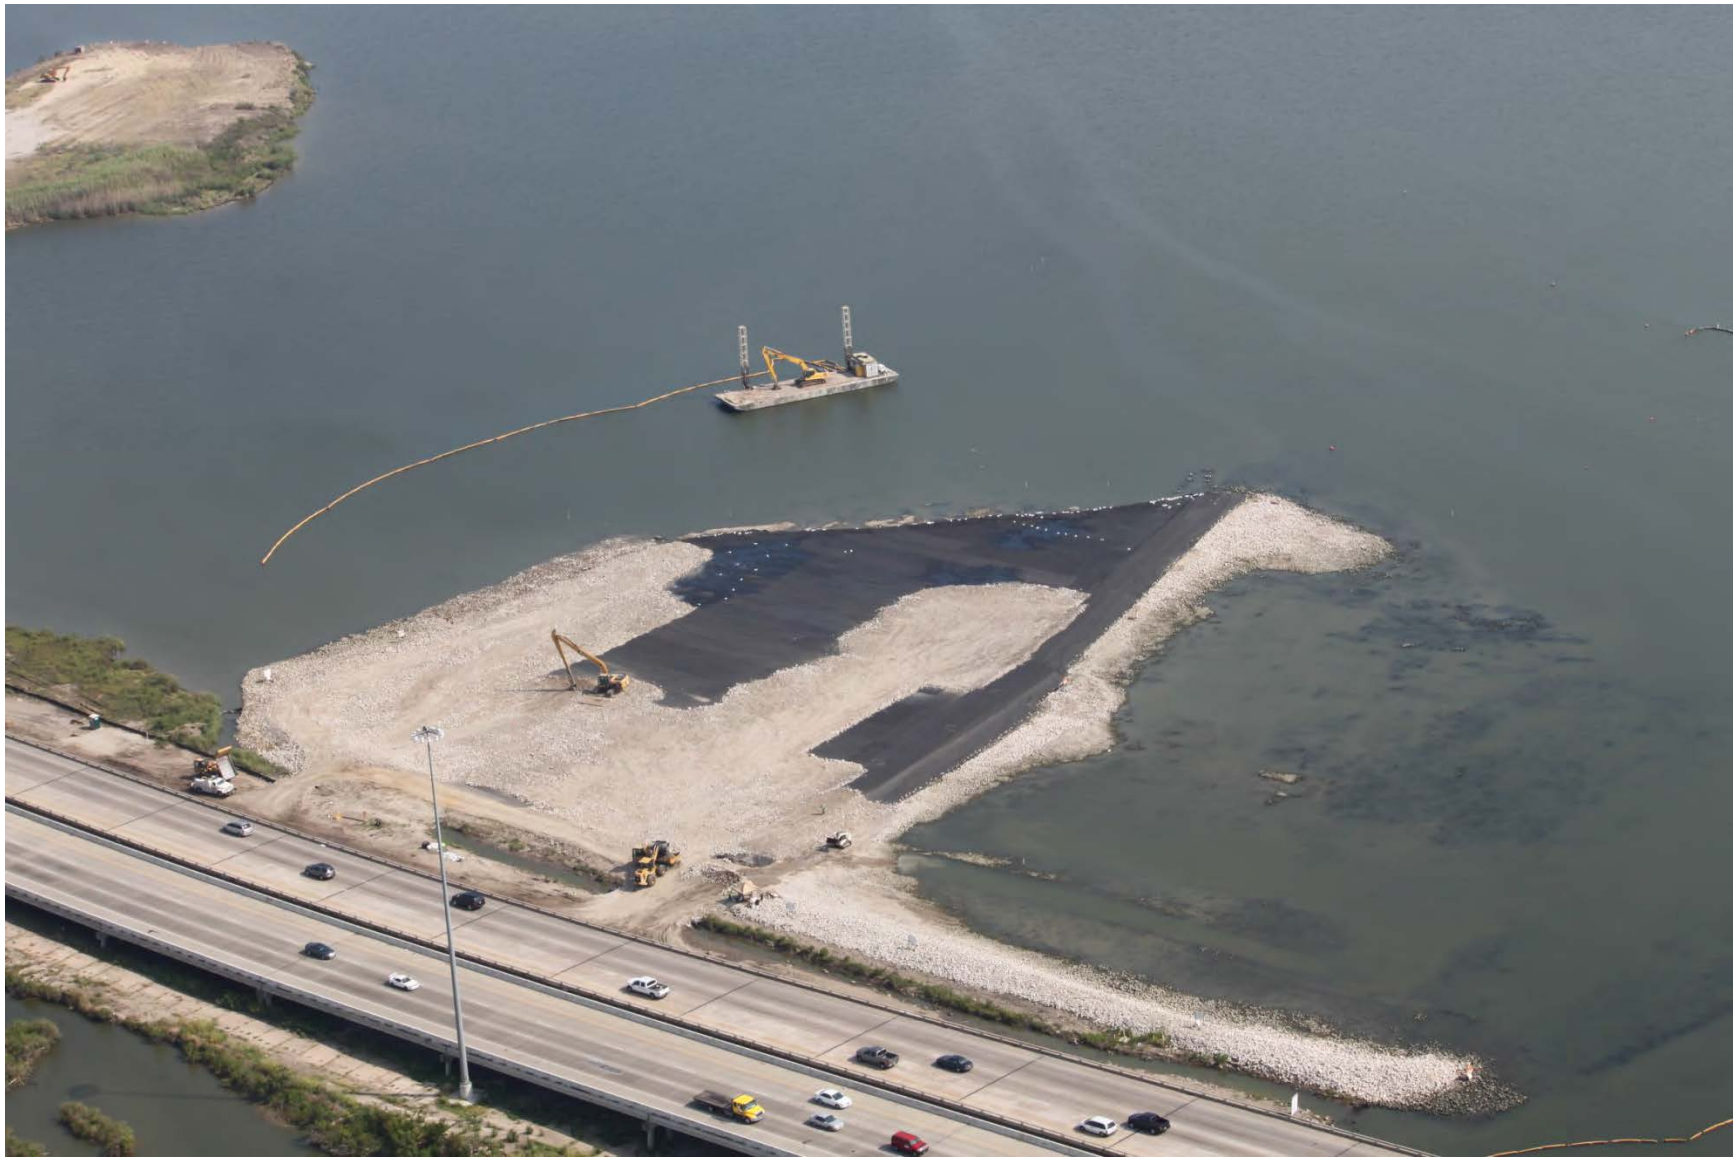
Project aerial photo dated June 9, 2011. Note geotextile over the geomembrane and stockpile area at juncture of central and southern berms.
